# Drop Test Results for the Combustion Engineering Model No. ABB-2901 Fuel Pellet Package

ASME/PVP Conference  
San Diego, CA, United States  
July 20, 2004 through July 25, 2004

## DROP TEST RESULTS FOR THE COMBUSTION ENGINEERING MODEL NO. ABB-2901 FUEL PELLET SHIPPING PACKAGE

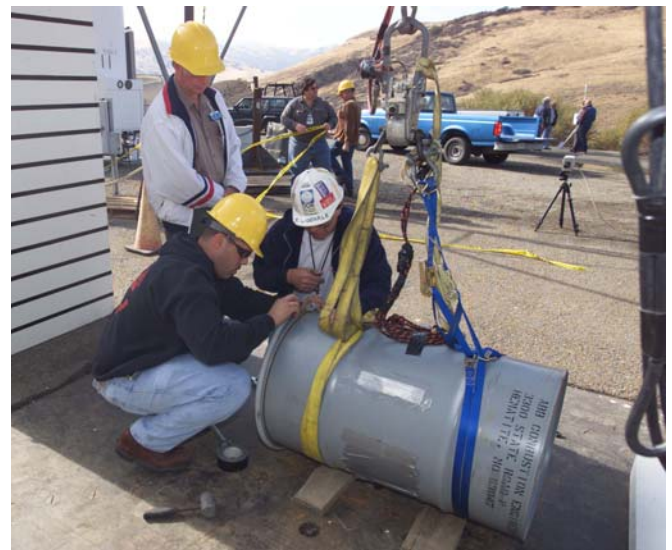
**Figure 2. Packaging Closure, Bldg. 858**

The fully loaded test package weighed 655 pounds, which is just below the licensed maximum total weight of the package of 660 pounds. When closing the drum after loading, a defect in the threads of the closure bolt stripped the threads in the tightening lug of the drum-closure ring, such that it could not hold the specified tightening torque of 75 ft-lbs. Thus the actual final weighing of the test package was not performed until shortly before the 30-ft drop test on November 15, when the LLNL team closed the drum with a replacement ring specially delivered from WEC-SC (see Fig. 2).

Note: The WEC-SC representatives specified the value of 30 ft-lbs for the closure nuts of the containment-box lid and the value of 75 ft-lbs for the drum closure ring bolt, since neither was specified in the SAR.

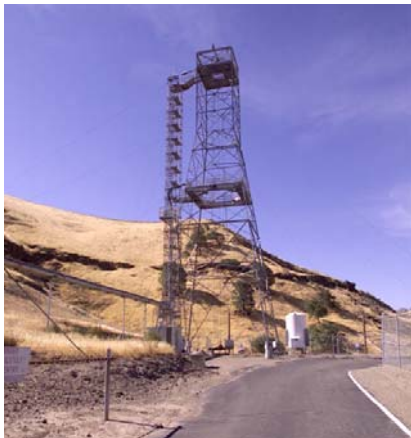
**Figure 3. Site 300 Drop Test Tower**

The Drop Tower Facility at LLNL's Site-300 (see Fig. 3), was used to perform the 30-ft drop test. The Facility was initially designed for drop testing heavy weapons-related packagings weighing up to 6,000 lbs, and is used to perform both guided and unguided (free) drops from heights up to 100 ft. The Facility has a ten-foot square unyielding surface built, from top to bottom, with (1) a top steel plate 3- 9/16" thick over (2) a 1" grout layer over (3) a 2 ft-thick reinforced

concrete pad over (4) a square, concrete tank back-filled with gravel approximately 5 ft deep. The Facility is more than adequate for the 30-ft drop test.

To ensure a free drop, the steel ropes used for guided drops were removed and pulled back prior to the setup for the 30-ft drop test. A single sling was used to suspend the package so that the effect of the release operation on the drop orientation could be minimized. For the 30-ft, 17.5° shallow-angle drop, the package was positioned and suspended according to the Test Plan. The position of the closure-ring lug for the test was changed from the original plan. The original plan called for the lug to be located 90 degrees, as opposed to the current 180 degrees, from the impact point. The 30-ft drop height was determined using a pre-measured plumb line. A pneumatic device released the suspension sling with the package. An attached long rope stopped the falling suspension sling before it caught up with the impacting package.

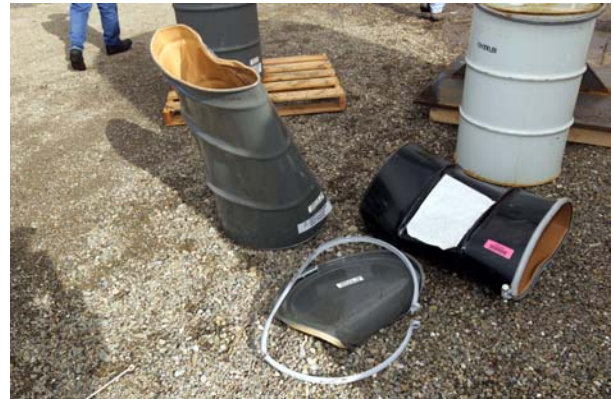
On the morning of November 14, the LLNL test team conducted two preliminary test runs of the 30-ft shallow-angle drop using two common 55-gallon drums as the test package. One drum was filled with water; the other with solid ice. The solid-ice test-drum package was produced by placing a 55-gallon drum of water overnight in an environmental test chamber. A thermocouple placed at the center of the drum cavity confirmed the formation of solid ice. As generally expected, the water-filled drum failed miserably. Figure 4 shows the

severely deformed drum components. The high hydrodynamic pressure generated by the impact apparently caused the large deformations. Being pushed outward, the drum body and lid deformed in the horizontal directions, which offered the least resistance.

**Figure 4. Damage to Lid, Closure Ring and Drum Along Side of Damage to Previously Dropped 35-Gallon, Water-Filled Drum**

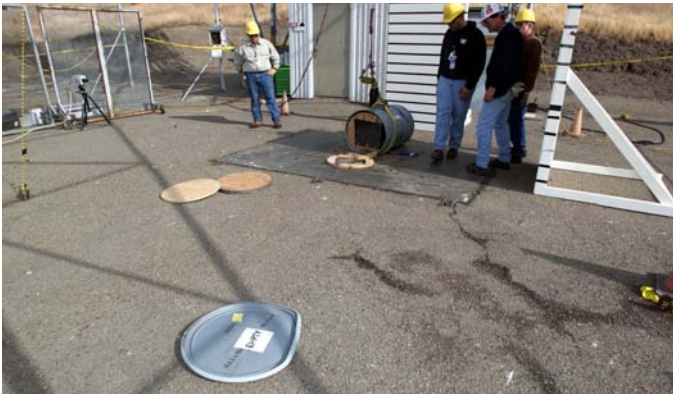
After the test team fitted the test drum with the replacement closure ring from WEC-SC, the ring-closure bolt was tightened to the recommended torque value of 75 ft-lb, which the WEC-SC had specified on November 13th. The test package was then properly positioned, suspended, and lifted to a height of 30 feet from the surface of the unyielding target. The package was dropped, and the test was completed, without any apparent difficulties with the operating procedures or the test hardware. The drum, however, failed with the lid enclosure ring completely separated from the drum.

Figure 5 shows the final position of all drum components after the drop.

**Figure 5. Post-test Component Orientation**

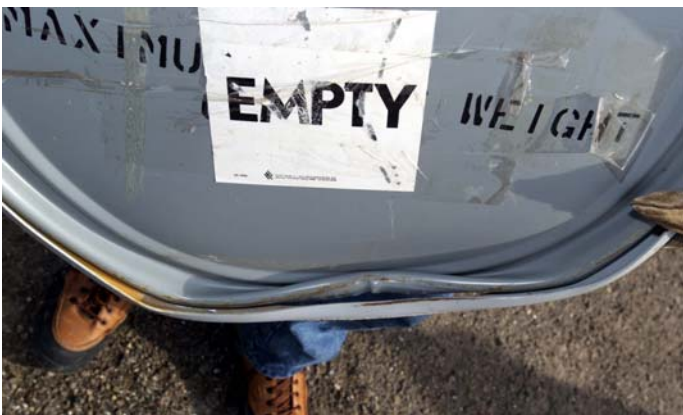
The lid and ring flew off together during the test and remained together after the test. They showed minimal out-of-plane deformation, i.e., they remained a planar structure. This indicates that the large buckling deformation of the lid-and-ring assembly that led to the separation of the assembly from the drum body was basically elastic. The assembly showed only large in-plane permanent deformation in the impact area. The impact produced an approximately 12-in.-long straight edge of the lid-and-ring assembly. The lid adjusted itself to this large in-plane deformation with minor out-of-plane local buckling, while the ring accommodated the large deformation by in-plane bending.

The two round solid plywood boards (one covered with a thermal insulation sheet), which occupied the space between the drum lid and the fuel-pellet containment box, suffered much less damage than their neighbors. This fact suggests that the boards had not borne or transmitted significant loads. Thus, their ejection from the impacting package consumed very little of the impact energy. Consequently, they were not able to contribute much to the ejection of the lid-and-ring assembly. Figures 6 and 7 show the damage suffered by the drum lid and upper drum body.

**Figure 6. Drum Lid Close-up (Top-down)**

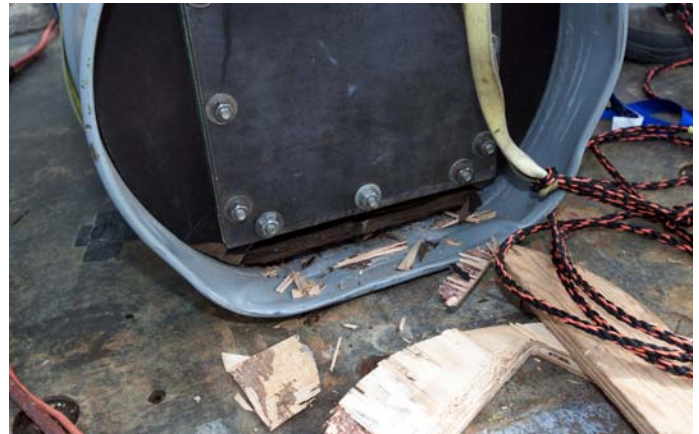
**Figure 7. Post-Test Upper Drum-Body Close-Up**

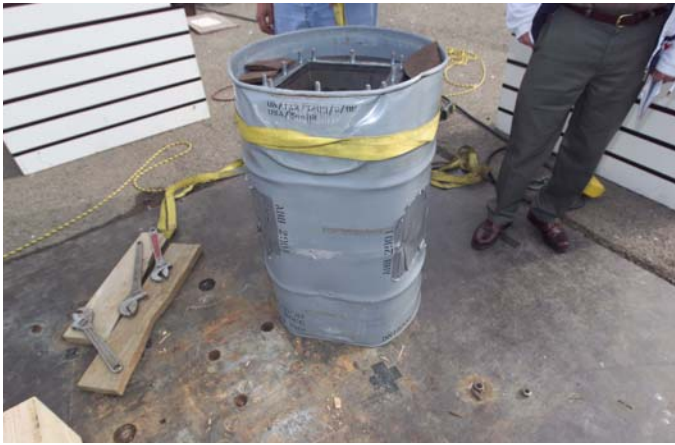
Similar to the lid-and-ring assembly, the round drum opening was flattened in the impact area. In addition, the round opening appeared slightly oval in the horizontal direction. This deformation was probably due to the compressive action of the vertical impact force rather than the bursting action of disintegrated contents, as in the case of the water-filled drum in the preliminary test runs.

The slight local buckling deformation of the drum opening near the impact area indicated the high intensity of the compressive action (see Fig. 8).

**Figure 8. Damage to Open Drum, Side View**
